# SERVICE BULLETIN

Service Bulletin No.: DAC1-73-03 Rev 0

Title: Engine Fuel Line Replacement – Filter to Throttle Body (IO240-B17B)

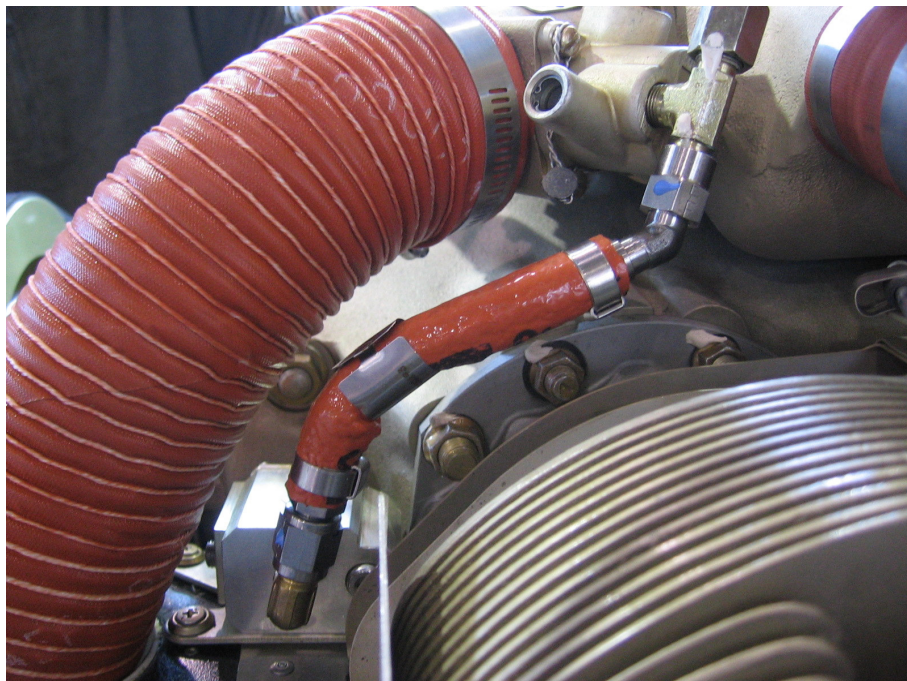
**Figure 1 – Fitting Orientation and Fuel Line Routing**

1. **ATA Code:** 7300
2. **Effectivity:** Serial Number C0380 to C0406, inclusive.
3. **General:** This service bulletin allows installation of an alternate fuel line on DA20-C1 aircraft with IO240-B17B engines to improve routing between the in-line fuel filter and the throttle body. This change has been incorporated by Teledyne Continental Motors on the IO240-B17B engines fitted to DA20-C1 aircraft, serial number C0407 and up.
4. **Compliance:** Optional/Recommended.
5. **Approval:** Engineering data referenced or contained in this service bulletin is approved as part of the type design.
6. **Labour:** Approximately 1 hour will be required to accomplish this service bulletin.

- 10.1 Remove and discard fuel line between in-line fuel filter on apron baffle and throttle body.
- 10.2 Remove and discard 45° fitting on outlet of in-line fuel filter.
- 10.3 Install AN822-4 (MS20822-4) 90° fitting on outlet of in-line fuel filter. Orient as shown in Figure 1.
- 10.4 Connect fuel line 646644S4Y5.00 fuel line to 90° fitting on fuel filter.

- 10.5 Flush fuel hose by inserting end of hose into a cup or bucket and turning prime pump on until fuel flows continuously from the hose.
- 10.6 Connect fuel line to throttle body. Orient as shown in Figure 1.
- 10.7 Do a check for fuel leaks.
