SERVICE BULLETIN

Service Bulletin No.: DAC1-74-01 Rev 0

Title: Ignition Harness Routing

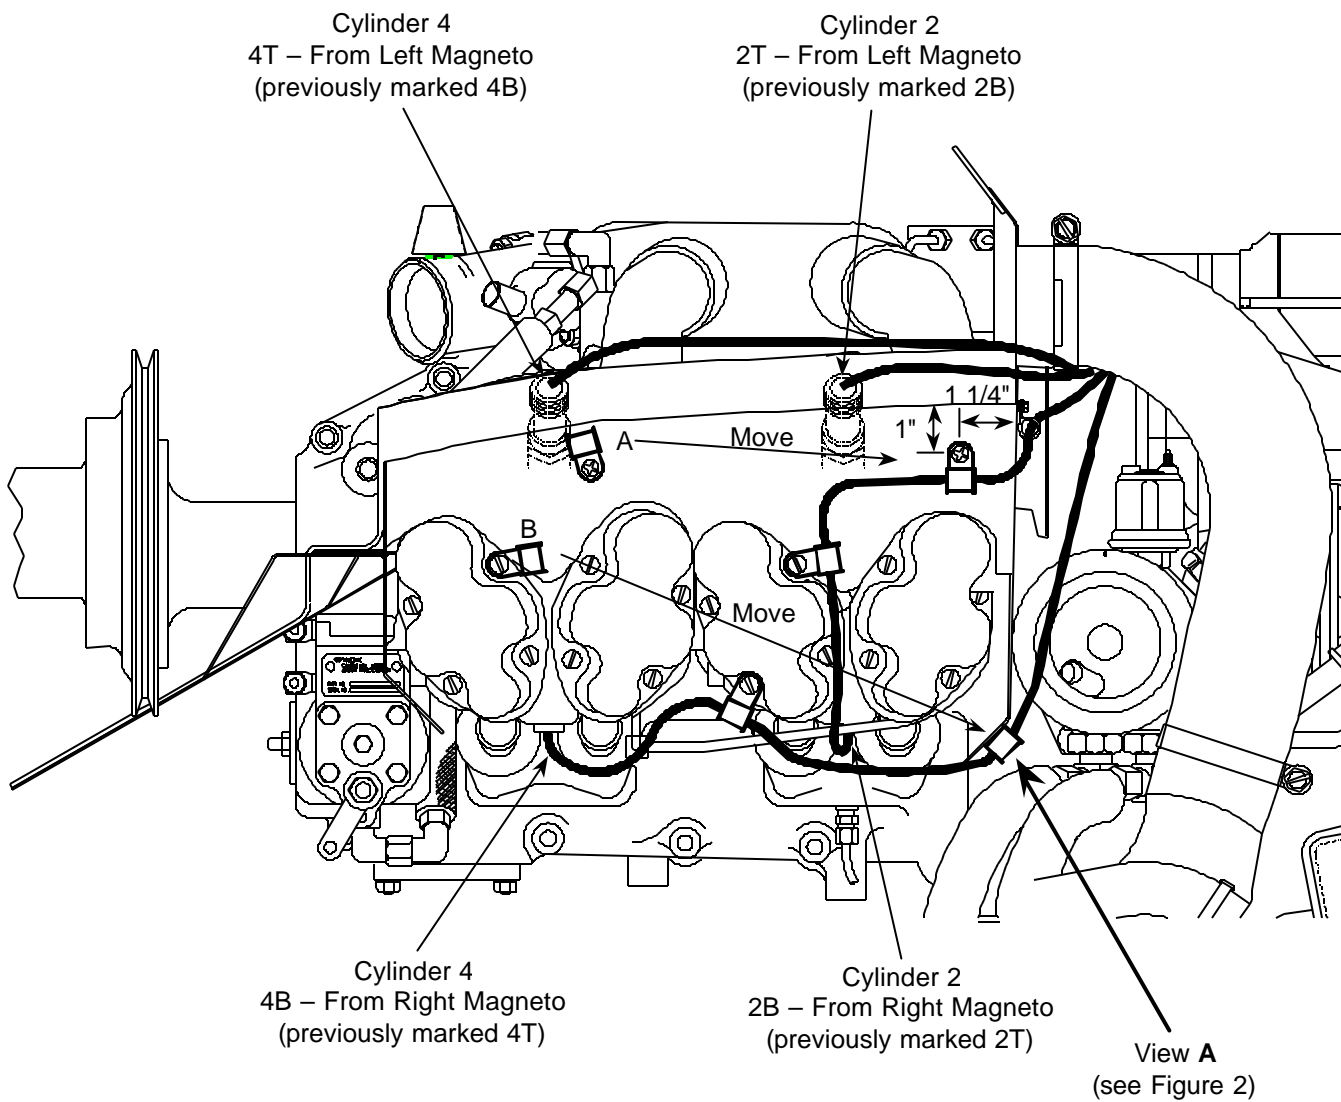
Figure 1
Left Side View of Engine

- 1. ATA Code:** 7420
- 2. Effectivity:** All DA20-C1 Aircraft.
- 3. General:** This Service Bulletin addresses a revision of the ignition harness wiring to improve cold weather starting. The revision consists of switching the spark plug leads from the top to the bottom.

- 10. Accomplishment Instructions:**
 - 10.1** Remove the cable ties from the harness behind the engine (Note the locations).
 - 10.2** Drill a #10 diameter hole 1¼" forward and 1" down from the upper aft corner of the right baffle (Figure 1).

- 10.3** Remove the cable clamp from location A and move it to the new location (Figure 1). The hole at location A may be sealed with suitable hardware or left open (cooling air leakage is negligible).

- 10.8** Reroute the harness as shown in Figure 1 and 3.
 - 10.9** Mark the ignition harness B nuts in accordance with SSI 99-4.
 - 10.10** Make a log book entry stating that this Service Bulletin has been incorporated.
