# SERVICE BULLETIN

Service Bulletin No.: DAC1-92-02, Rev. 0

Title: Certification, United Kingdom Import Requirements

1. **ATA Code:** Not Applicable
2. **Effectivity:** DA20-C1 s/n C0001 and subsequent, for operation under UK registry.
3. **General:** This bulletin describes modifications required for aircraft operation under United Kingdom registry.
4. **Compliance:** Prior to the issue of a UK Certificate of Airworthiness.
5. **Approval:** Data referenced or contained in this service bulletin is CAA (UK) approved.
6. **Labour:** N/A

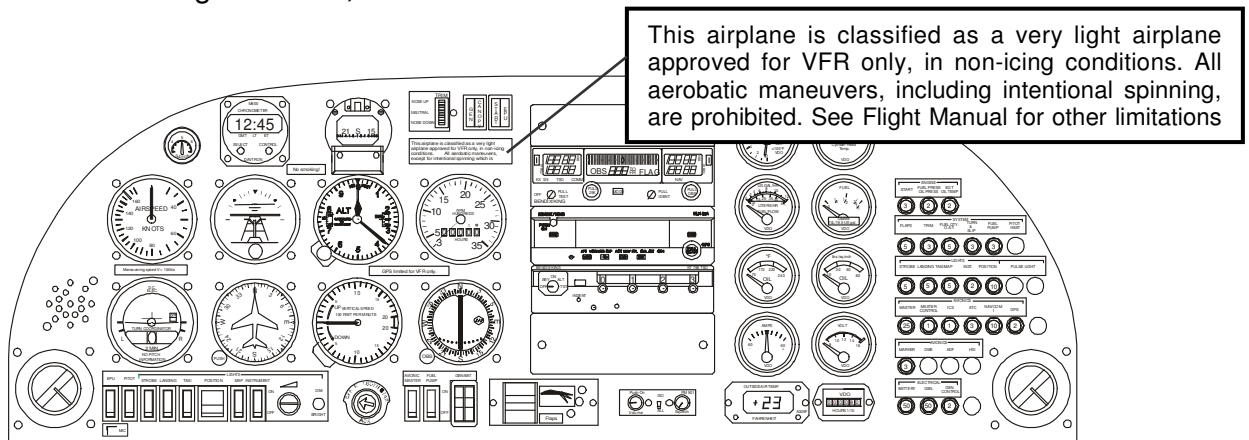
Figure 1 – VLA Label placement on the instrument panel

- 10.1 **Label** - Insure the VLA label (spinning prohibited) is correctly installed, as per the flight manual, document DA202-C1.
