# SERVICE BULLETIN

Service Bulletin No.: DA20-24-02, Rev. 0

Date Issued: January 8, 1996

Title: DC Generation, ( Improved Generator Grounding )

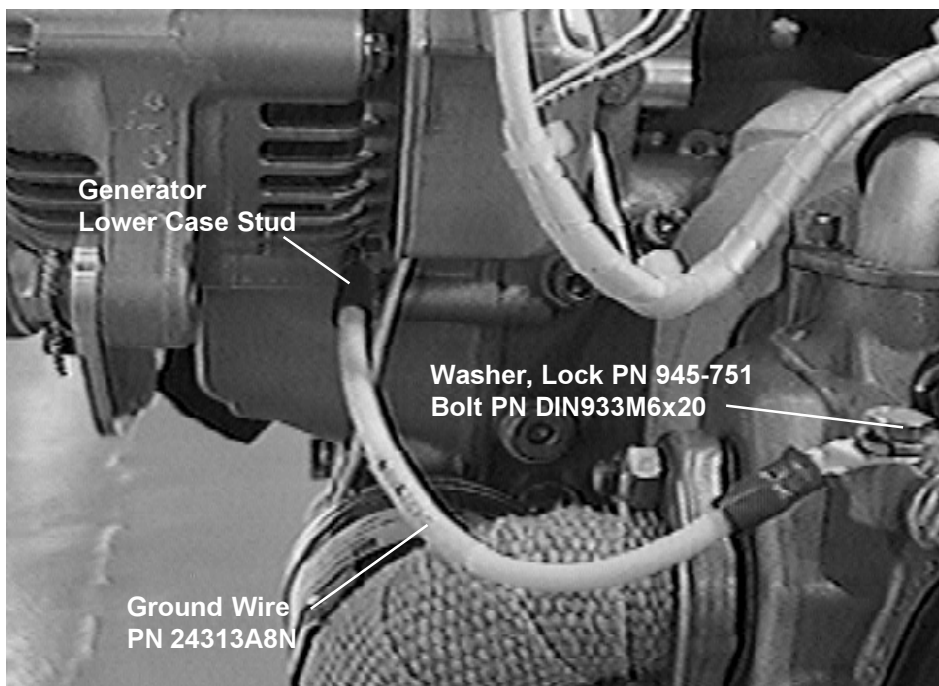
Figure 1 (Ref. DAI Drawing #20-2400-06-01, Rev. b)

1. **ATA Code:** 2430
2. **Effectivity:** All DA 20 Katana Aircraft up to and including serial number 10045.
3. **General:** The ground return for the generator and generator fail indication is currently supplied through the generator mounting brackets. The addition of a chassis grounding wire from the generator directly to the engine is required to ensure adequate grounding.
4. **Compliance:** Incorporation of this Service Bulletin is highly recommended by Diamond Aircraft and should be accomplished at the operator's earliest opportunity.
5. **Approval:** Engineering data referenced or contained in this bulletin is Transport Canada approved.
6. **Labor:** Approximately 0.5 man hour.
7. **Material:**

- 10.2 Ensure all electrical contacts areas are clean.
  - 10.3 Remove lower case bolt from generator. Place the lower case bolt through the grounding wire ring terminal and re-install the bolt into the generator housing.

- 10.4 Place the supplied bolt and lock washer through the grounding wire ring terminal and install in the # 2 cylinder head casting threaded hole located on the top forward outboard part of the cylinder.

- 10.5 Route the wire clear of the exhaust pipe.
  - 10.6 Ensure the engine compartment is clear of foreign materials and re-install the engine cowlings.
