SERVICE BULLETIN

Service Bulletin No.: DA20-72-02 Rev 0

Title: DA20-A1 – Evans NPG+ Coolant

CHANGE OF COOLANT SPECIFICATION ON ROTAX® ENGINE TYPE 912 AND 914 (SERIES)

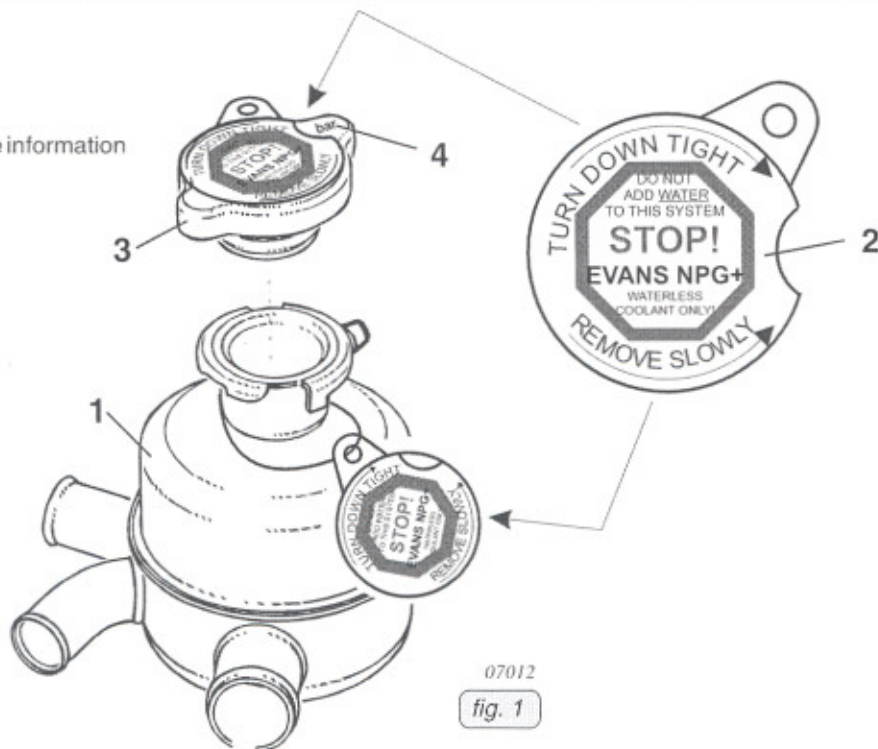
◆ **NOTE:** On the radiator cap (3), to identify the new coolant, the warning label (2) is to be affixed so that the opening pressure data (4) is visible.

- For new engine deliveries the sticker will be temporarily attached to the expansion tank.
- The sticker has to be affixed to the radiator cap in accordance to the aircraft manufacturer's instruction.

- 1 Expansion tank
- 2 Warning sticker
- 3 Radiator cap
- 4 Excess-pressure information
