SERVICE BULLETIN

Service Bulletin No.: DA20-79-03 Rev 1

Title: Oil Dipstick, Thermal Insulator

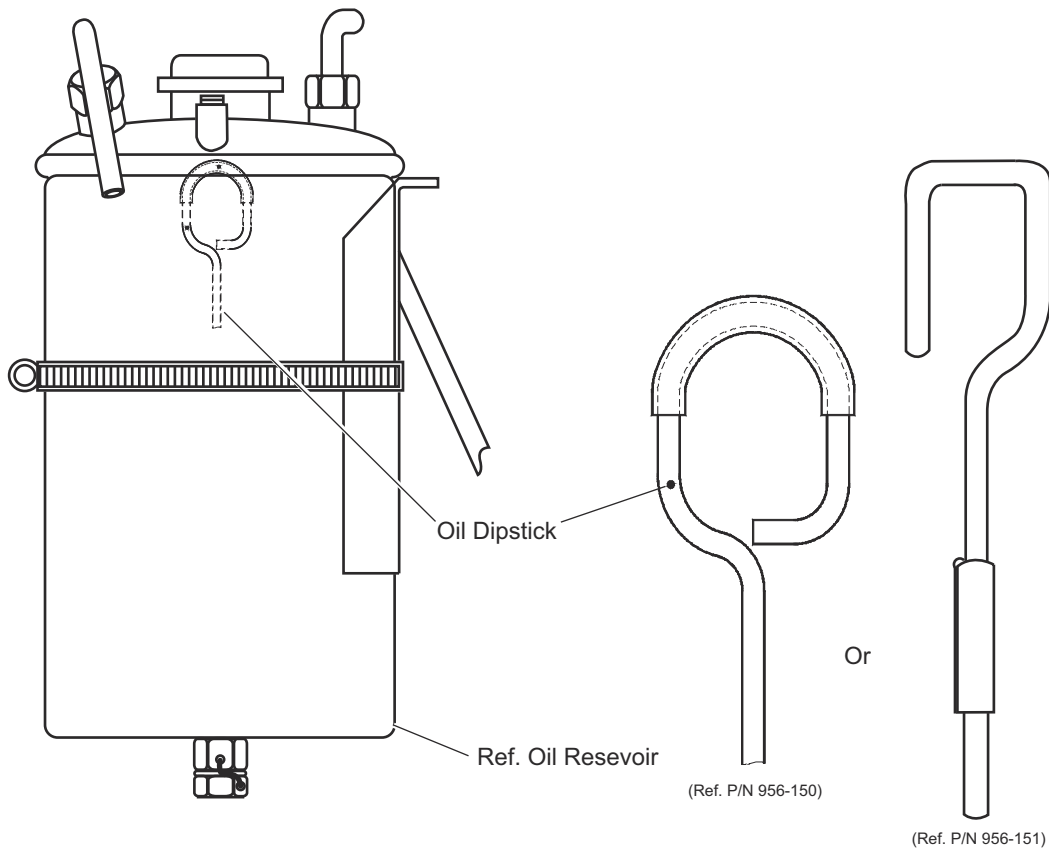
Figure 01 - Oil Dipstick Installation

- 1. **ATA Code:** 3310
- 2. **Effectivity:** All DA 20 Katanas, up to and including Serial number 10056.
- 3. **General:** This bulletin describes the installation of a thermal Fluran insulator tube over the handle of the Rotax 912 oil dipstick.
- 4. **Compliance:** Compliance with this Service Bulletin is recommended.
- 5. **Approval:** Engineering data referenced or contained in this service bulletin is approved as part of the type design.
- 6. **Labour:** Approximately 0.30 man-hour will be required to accomplish this Service Bulletin.

- 10.1 Remove the upper cowling from the aircraft.
- 10.2 Remove the oil reservoir cap.
- 10.3 Remove the oil dipstick.
- 10.4 Use a bench vise to open bend, lubricate handle with engine oil and slide Fluran tubing on to distick as shown in Figure 1.
- 10.5 Close bend to its original shape.
- 10.6 Ensure Fluran tube is located evenly on the top of the handle.
- 10.7 Make a log book entry that this Service Bulletin has been incorporated.
