SERVICE BULLETIN

Service Bulletin No.: DA20-79-08 Rev 1

Date Issued: October 22, 2011

Title: Introduction of a new Oil pressure Indicator

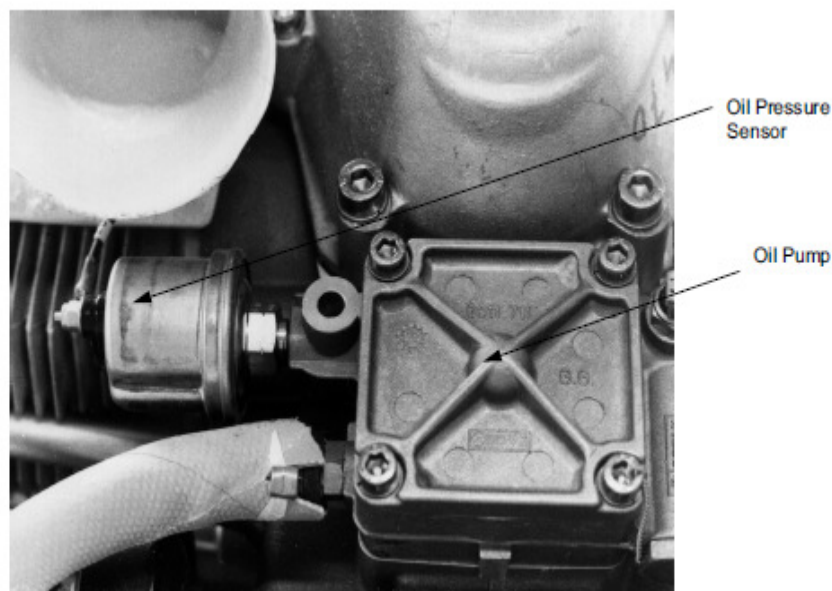
NOTE: For aircraft serial number 10145 and subsequent, or aircraft with Service bulletin DA20-79-01 incorporated, Oil Pressure Sensor located on firewall (Aft RH engine compartment). Install Oil Pressure Sensor with Loctite 222 or Sealube. Torque to 30Nm (22.1 lbF·ft) (maximum).

- 10.1.1 Remove the Oil Pressure Sensor. Refer to AMM, Chapter 79-30.
- 10.1.2 Install new Oil Pressure Sensor (p/n 956413) in accordance with ROTAX Maintenance Manual (Heavy Maintenance Manual), latest approved revision.

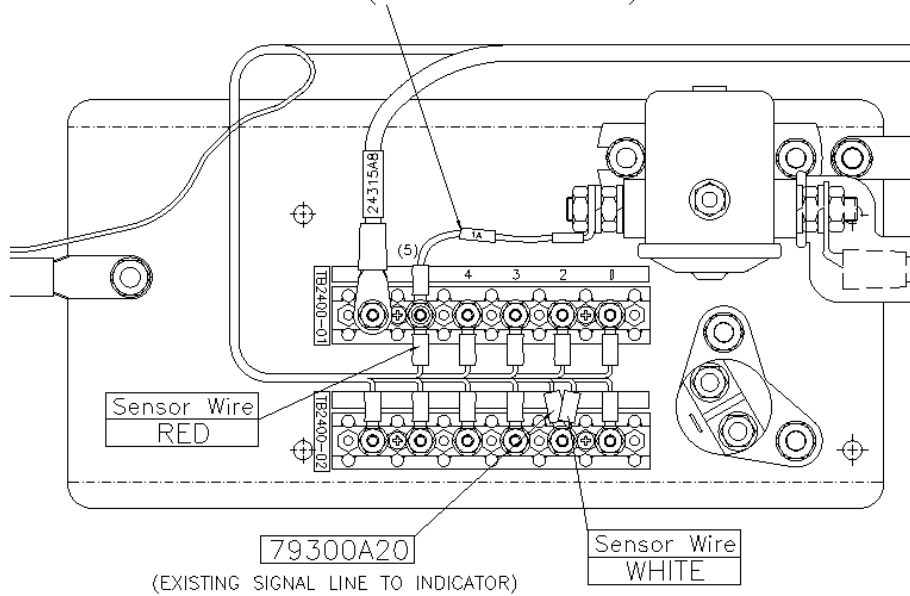
FUSE ASSEMBLY (20-7931-00-00)

p/n 956413 Sensor Wire	Location
RED	TERMINAL POST #5 on Terminal block TB2400-01
WHITE	TERMINAL POST #2 on Terminal block TB2400-02
BLACK	CAP AND STOW

10.2.3 Connect new Oil Pressure Sensor wires to electrical shelf as shown below. Cap and stow BLACK.

10.2.4 Install Fuse Assembly (p/n 20-7931-00-00) from battery relay to terminal block post #5 as shown below.
