SERVICE BULLETIN

Service Bulletin No.: DA20-79-05 Rev 2

Title: DA20 A1 - Oil Line Retrofit – F3 Engine

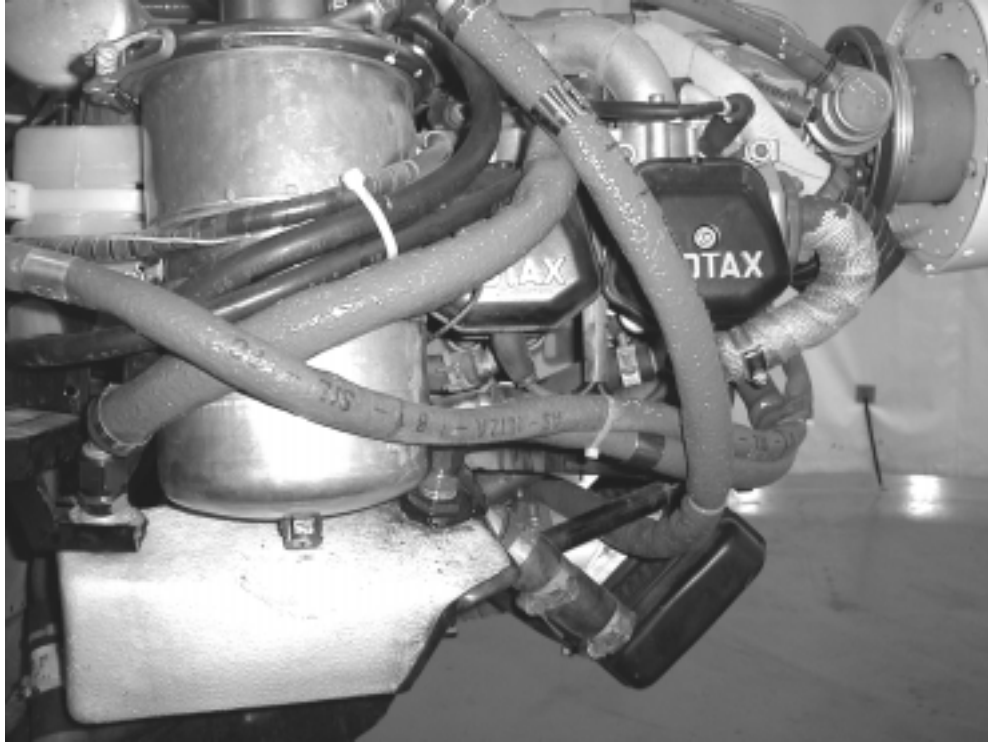
Figure 2: Routing and securing oil lines (RH, looking inboard).

- 10.8** Route and secure oil lines as shown in Figures 2 and 3 using supplied tie-down straps, MS3367-5-9. ORIENT FITTINGS AND HOSES TO AVOID CONTACT WITH RADIATOR, ENGINE MOUNT AND CABIN HEATER SHROUD.
- 10.9** Ensure reservoir is in lowest position on engine mount. Do not allow reservoir to contact oil cooler shroud or upper surface of coolant overflow bottle.
- 10.10** Connect oil reservoir vent line.
- 10.11** Install slotted head screw M10X1X8, (p/n 440 061 not supplied) using Loctite 222 in open port of reservoir cover in accordance with Spare Parts List.

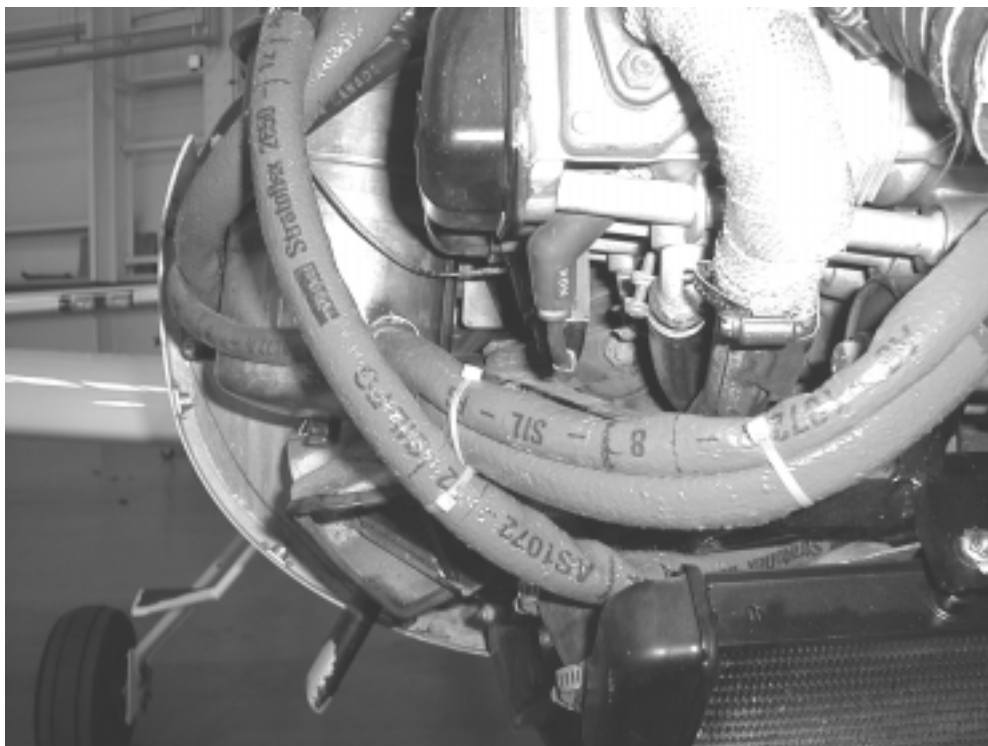
Figure 3: Routing and securing oil lines (front, looking aft).
