SERVICE BULLETIN

Service Bulletin No.: DA20-79-07 Rev 0

Title: Oil Quantity Placard DA20-A1/DA20-100

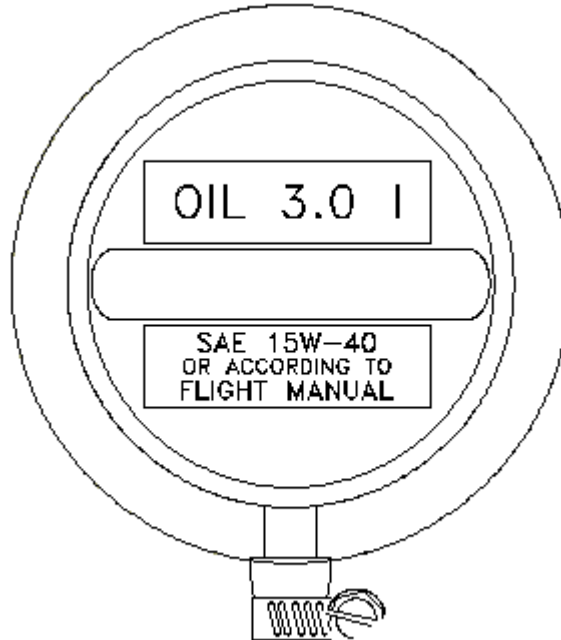
Figure 1
Old Placard

1. **ATA Code:** 7900
2. **Effectivity:** Diamond Aircraft Model DA20 A1 aircraft.
3. **General:** Rotax has specified the use of a new oil dipstick that increases the oil capacity of the 912 A/F/S series engines (SB-912-040 R1). As a result, the oil capacity placard located on the oil reservoir cap must be replaced.
4. **Compliance:** At the next oil change or within the next 100 hours of operation, but at the latest by November 30,2003.
5. **Approval:** The engineering data referenced or contained in this service bulletin is approved as part of the type design.
6. **Labour:** Approximately 5 minutes will be required to accomplish this service bulletin.
This estimate is for direct labor performed by a technician and it does not include setup, planning, familiarization, cure time, part fabrication or tool acquisition.

- 10.1 Remove the existing placard from the oil reservoir cap.
- 10.2 Clean the surface of the oil cap, removing all traces of adhesive, oil or dirt.
- 10.3 Remove the foil backing from the new placard and apply the placard to the oil reservoir cap in the same location and orientation as the existing one.
