SERVICE BULLETIN

Service Bulletin No.: DA20-79-05 Rev 3

Date Issued: January 19, 2009

Title: DA20 A1 - Oil Line Retrofit - F3 Engine

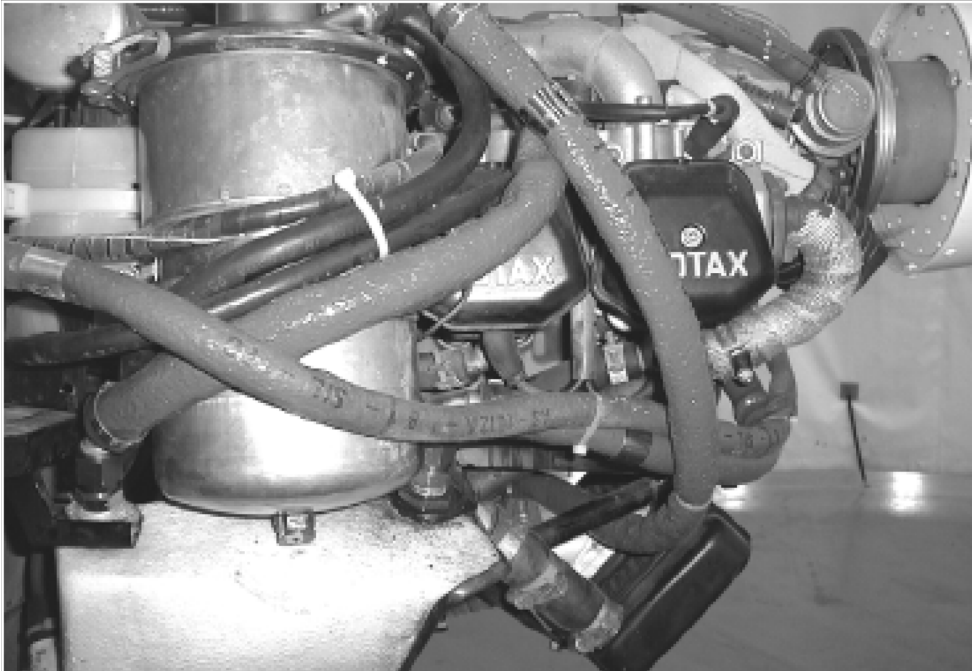
Figure 2 - Routing and securing oil lines (RH, looking inboard)

- 10.8 Route and secure oil lines as shown in Figures 2 and 3 using supplied tie-down straps, MS3367-5-9. ORIENT FITTINGS AND HOSES TO AVOID CONTACT WITH RADIATOR, ENGINE MOUNT AND CABIN HEATER SHROUD.
- 10.9 Ensure reservoir is in lowest position on engine mount. Do not allow reservoir to contact oil cooler shroud or upper surface of coolant overflow bottle.
- 10.10 Connect oil reservoir vent line.

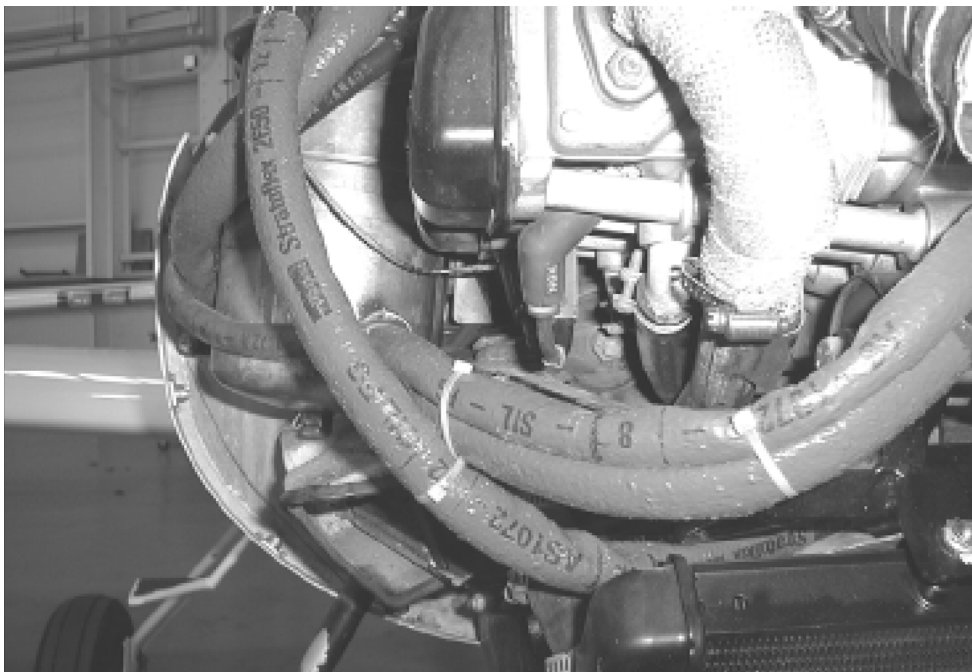
Figure 3 - Routing and securing oil lines (front, looking aft)
