# SERVICE BULLETIN

Service Bulletin No.: DA20-77-01, Rev. 0

Title: Tachometer, Cable Assembly, Inspection.

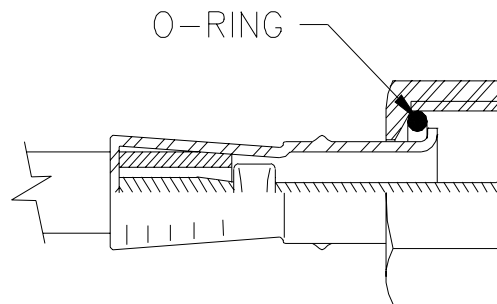
FIGURE 1.

11.1.4 Ensure that the O-Ring is installed at the Engine end of the cable.
