# SERVICE BULLETIN

Service Bulletin No.: DA20-27-02, Rev. 0

Title: Trim Display Modification.

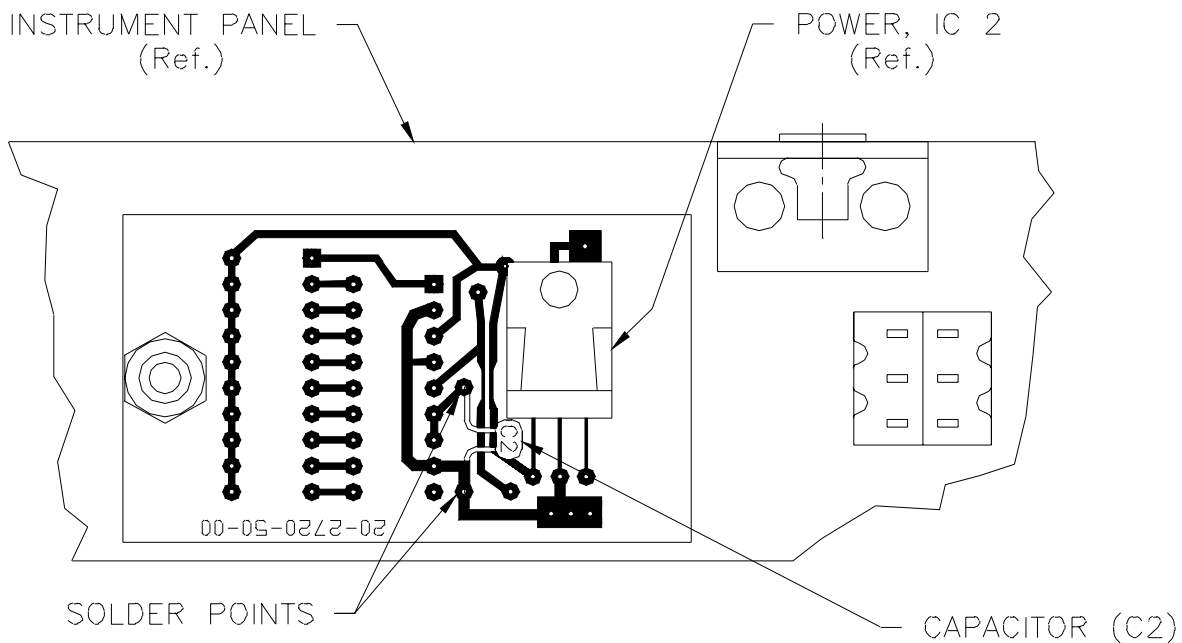
FIGURE 1.

3. General: The existing Trim Indicator flickers when the VHF Transceivers are transmitting. This usually occurs in the higher end of the frequency range. The installation of this Service Bulletin will eliminate this occurrence.

BOARD VIEWED FROM SOLDER SIDE

11.1.3 Solder the Capacitor (C2) to the back of Trim Display as shown in Figure 1. It is important that the leads of the Capacitor are kept as short as possible. Make sure that the solder used is a resin core type.
