SERVICE BULLETIN

Service Bulletin No.: DA20-28-01 Rev 0
Title: Fuel Cap, Safety Chain

Date Issued: August. 26, 1996
Page: 1 of 3

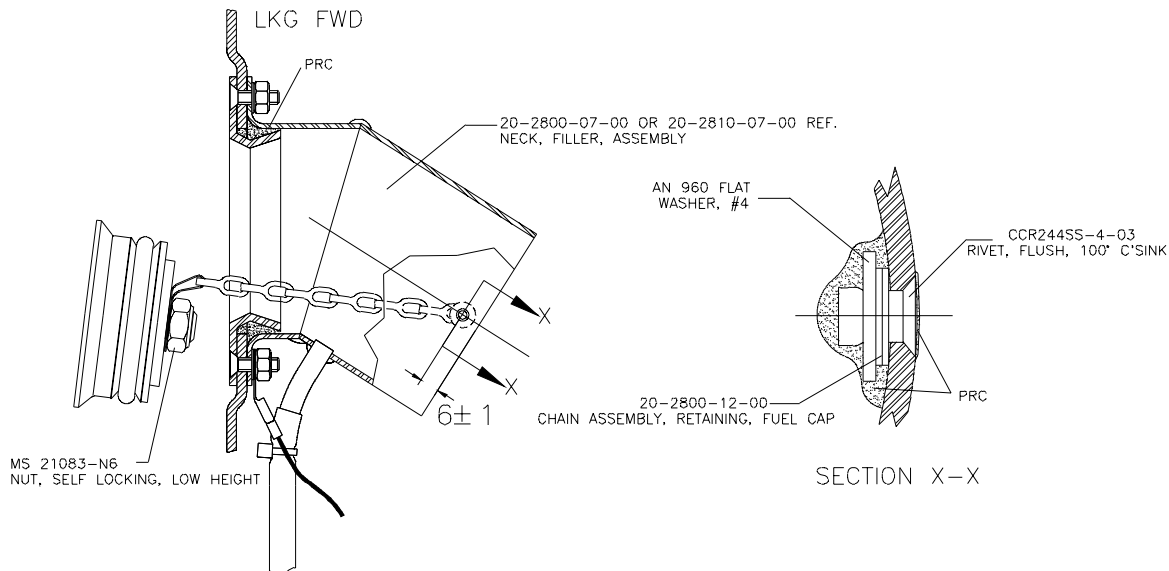
FIGURE 1.

3. General: The existing Fuel Filler Cap (P/N UD-3F) requires frequent lubrication of the O-ring seal, under high usage conditions. Failure to lubricate the seal may cause loss of fuel cap security. This bulletin describes the installation of a fuel cap safety chain.

- ### 10.2. Filler Neck Modification:
- 10.2.1 On the aft side of the filler neck (i.e. closest to the B-Bulkhead) drill a .125" / .129" hole in the filler neck shown in Figure 1.
 - 10.2.2 Countersink the .125" / .129" hole so that the rivet will just sit flush to the filler neck O.D. Deburr the hole.

- 10.2.3 Rivet the chain assembly to the filler neck as shown in the section view.
- 10.3 Resealing the Installation:**
 - 10.3.1 Seal rivet with PRC fuel sealant inside and out as shown in section view.
The coating on the filler neck O.D. should be spread flush.
 - 10.3.2 Ensure all grounding straps and vent tubes are properly installed and sealed per the maintenance manual.
 - 10.3.3 Re-install the filler hose apposite to 10.1.2.
 - 10.3.4 Attach fuel cap to chain tab and re-install nut. Nut is in safety when one thread is showing. Note: Inspect nut locking element. If it can be fully finger tightened replace. (ref AC 43.13 1A/2A)
 - 10.3.5 Lubricate fuel cap O-Ring (Fuelube or Vaseline is recommended) and install fuel cap.
 - 10.3.6 Re-install baggage floor
